Manhole Inspection Summary

Manhole # S49U1_002MH

Insp Date: **6/4/08 11:18 AM**

Location Address: **3100 Frankfurst Ave.**

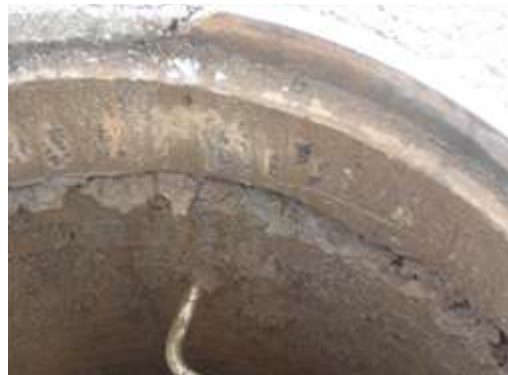
Defect 2

Condition: **Broken**

Condition: ☐ Sound ☒ **Cracked** ☐ Leaks

Broken Frame and deteriorated
Frame-Chimney joint.

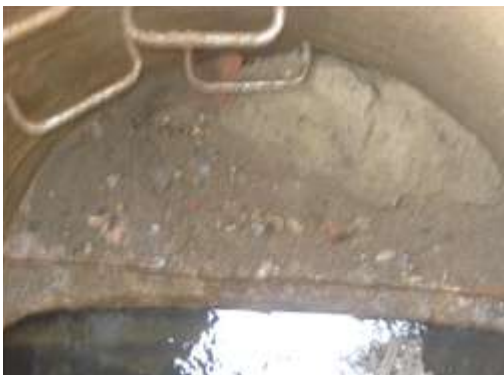
Defect 1

Condition: ☐ Sound ☐ Cracked ☐ Root Intrusion ☐ Deteriorated ☐ Leaks ☒ **Debris**

Debris on bench

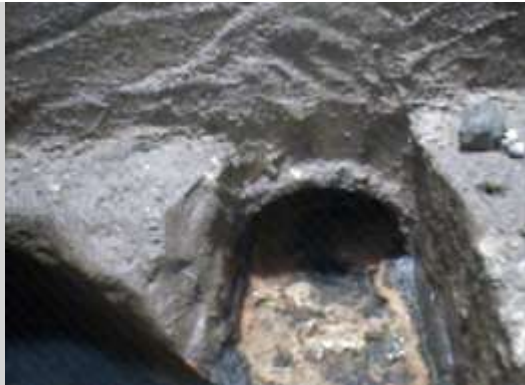
7 O'Clock Inflow

Deposits: ☐ None ☒ **Mud** ☐ Sludge ☐ Debris ☐ Grease

Silt Depth: **1** (in.) Deposits Extent: **Light**
